PROJECT:
LEICHHARDT PARK CHILD CARE CENTRE

DRAWING TITLE:
HYDRAULIC SERVICES DETAILS SHEET 2

DRAWING SCALE:
 NTS
DRAWING No. H08
 DRAWN: MT
 DESIGNED: TK
 APPROVED: TO
 SHEET: 9 OF 9
 JOB NUMBER: 14226
 REV: 1

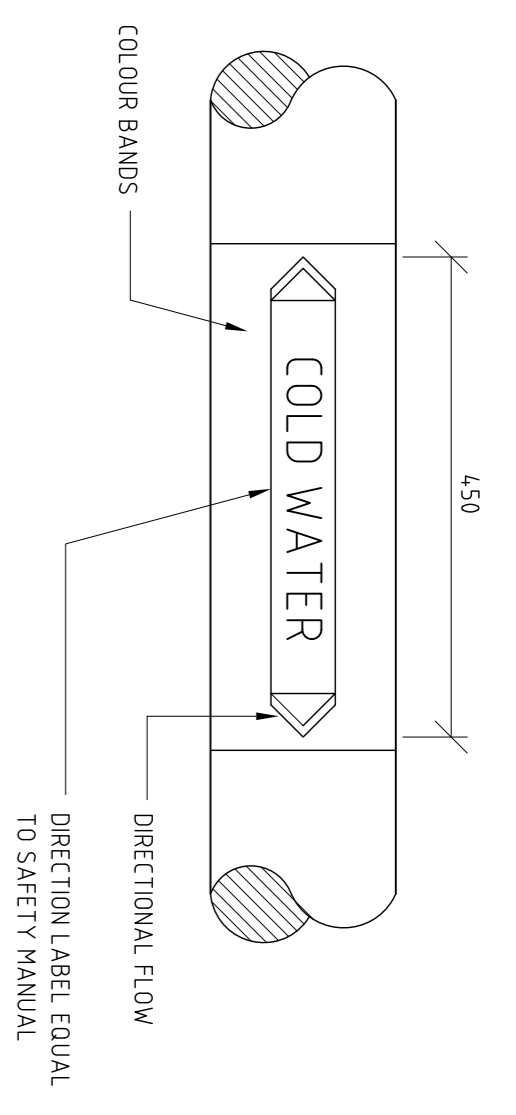
PIPING IDENTIFICATION DETAIL

ALL OTHER EXPOSED PIPING EXCEPT AS OTHERWISE DIRECTED OR SPECIFIED BELOW SHALL BE CLEANED FREE OF CEMENT DROPPINGS, ETC. AND BE PAINTED IN ACCORDANCE WITH A 5.134.5-1972, B 5.381C-1967 AND THE COLOUR CODING INDICATED BELOW.

SERVICE	GROUNDING COLOUR	No.
DOMESTIC COLD WATER	EMERALD GREEN	228
FIRE SERVICE DOWNPIPES	SIGNAL RED	537
HOT WATER	ROOF COLOUR/BOND BRILLIANT GREEN	-
SOIL WASTE VENT	BLACK	221
