Arboricultural Impact Assessment of Proposed New Childcare Centre

Leichhardt Park, Lilyfield

Date: June 2014

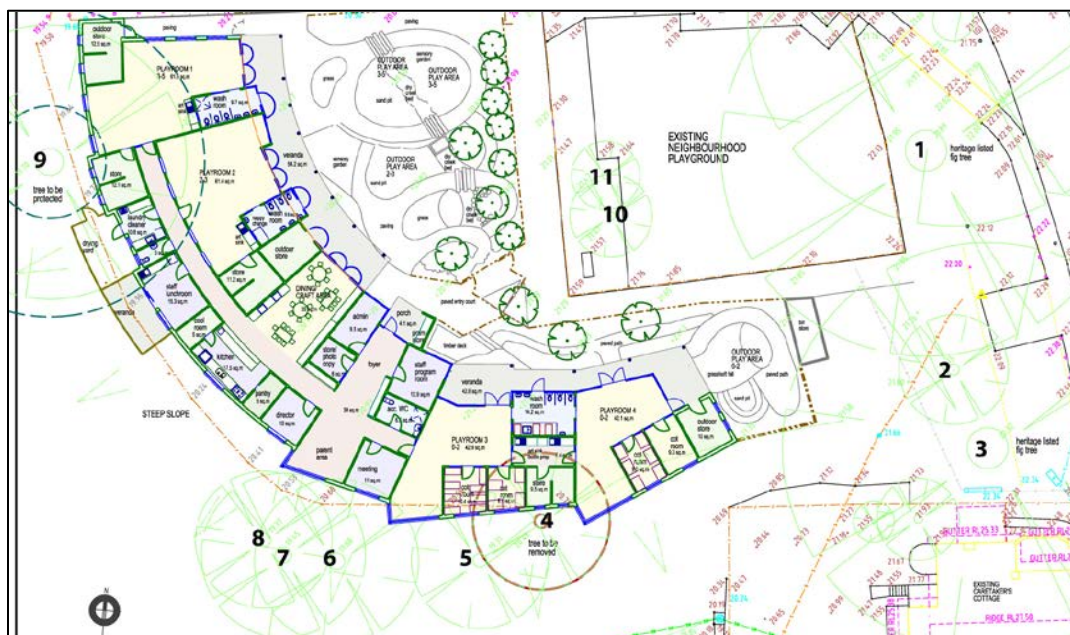
Figure A: Excerpt from the Site and Floor Plan showing tree locations and numbering.

Refer to Figure A below for tree locations and numbers. A detailed description of the subject trees is included in the Tree Assessment Table (Attachment A).

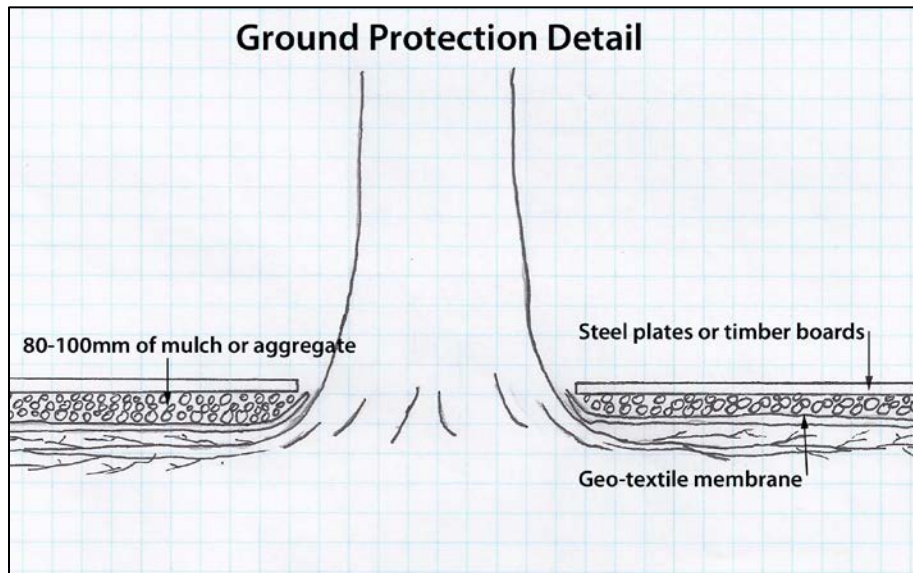
Figure B: Specification of appropriate ground protection –To be used where construction access passes within the TPZ of Trees 1, 2 and 3.

Specification of ground protection and trunk battening is detailed in Figure B on the following page:

As it is often not feasible to fence off the entire Tree Protection Zone, ground protection and trunk battening as specified in Figure B should be used in areas where fencing is not possible.

Ground Protection: Ground protection is recommended for the likely construction access-way through the existing park maintenance gate. Ground protection is aimed at preventing soil compaction, soil contamination, damage to surface roots and disruption of the natural soil profile.

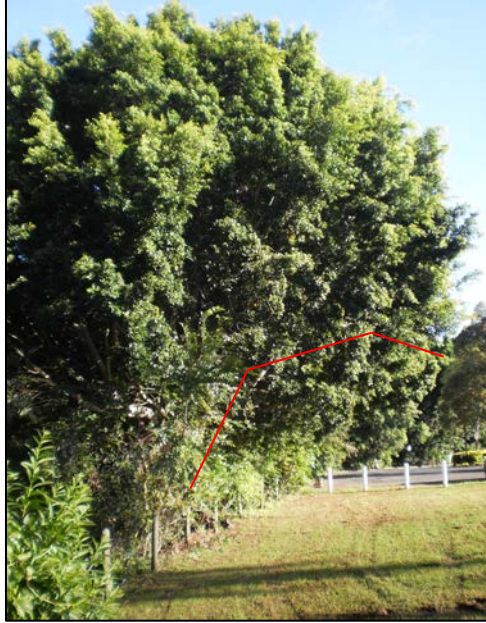
Photo A: Approximate area of the canopy that is required to be pruned.

Tree Pruning: Pruning of Tree 9 is required to raise the canopy height on the eastern side for construction and roof clearance (Photo A). No more than 10% of the total canopy will be removed as part of these works. Pruning works must be undertaken in accordance with AS 4373-2007-*Pruning of amenity trees*, Section 7.3.3 (Crown Lifting). Only those branches with the potential to conflict with building works should be removed.
