Arboricultural Impact Assessment of Proposed New Childcare Centre

Leichhardt Park, Lilyfield

Date: June 2014

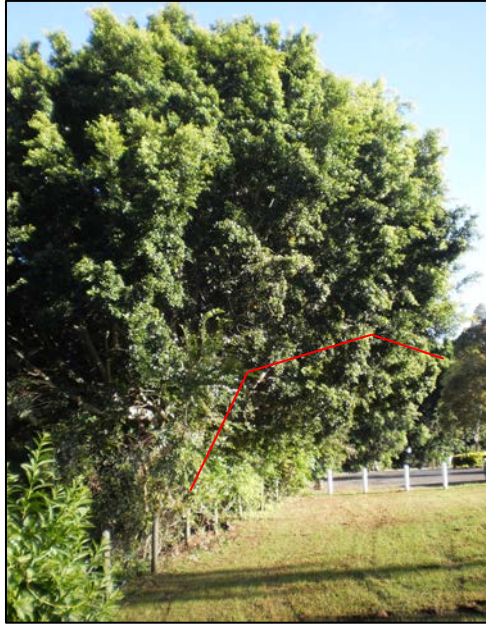
Photo A: Approximate area of the canopy that is required to be pruned.

Tree Pruning: Pruning of Tree 9 is required to raise the canopy height on the eastern side for construction and roof clearance (Photo A). No more than 10% of the total canopy will be removed as part of these works. Pruning works must be undertaken in accordance with AS 4373-2007-*Pruning of amenity trees*, Section 7.3.3 (Crown Lifting). Only those branches with the potential to conflict with building works should be removed.

It is recommended that floor level of the north-eastern section of the proposed building (within the TPZ of Tree 9) be sufficiently elevated to allow a void between the existing ground level and under-side of the floor slab. Excavation should be limited to pier footings. The area of excavation for a ground floor slab should be limited to less than 10% of the TPZ area of Tree 9 (refer to the Tree Protection Plan- Attachment A).
